**ADAPTIVE MITIGATION MANAGEMENT APPROACH**

# **University of Southern California**

## **2030 Master Plan**

*May 2011*

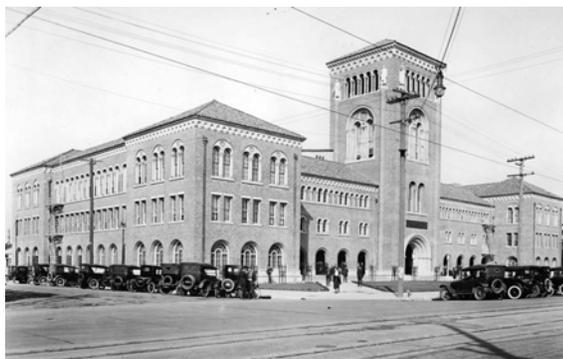
The first building to be constructed as part of the campaign was the Bovard Administration Building (ADM), a three-story brick and concrete building with a complex, symmetrical plan. Dominated by a massive central tower, Bovard's facade is ornamented with a number of large sculptures of heroic figures by Casper Gruenfeld.

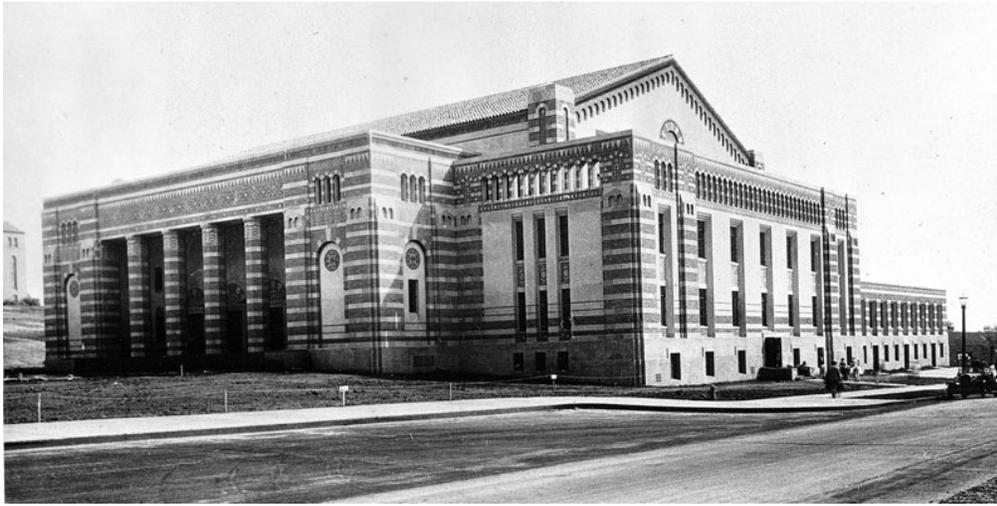
Physical Education Building

The exterior surfaces of the building are in generally good condition with select areas of deterioration, including surface staining, spalling, weathering, corrosion, and missing mortar.

The clay tile roof is in fair condition, with damaged sections near the edges of the weight station and the ROTC stations. Repair or replace tiles in kind as needed.

There is staining and spalling of the cast stone and brick cladding. The damaged areas should be cleaned and repaired.

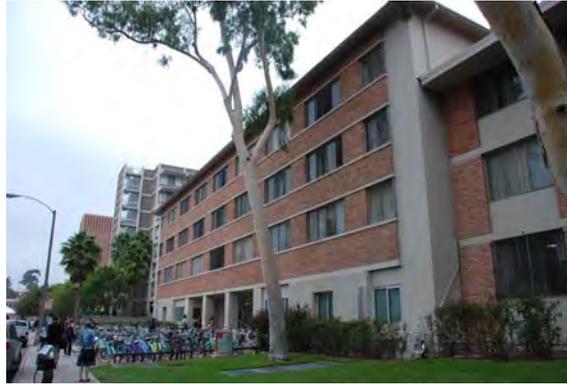
Von KleinSmid Memorial Residence Hall

The Von KleinSmid Residence Hall (1950), which was designed by Samuel E. Lunden, also has International Style elements such as regularly spaced fenestration framed with horizontal concrete bands. Similar to Taper Hall, the Von KleinSmid Residence Hall has a facade of red brick and concrete while

adhering to an International Style vocabulary.

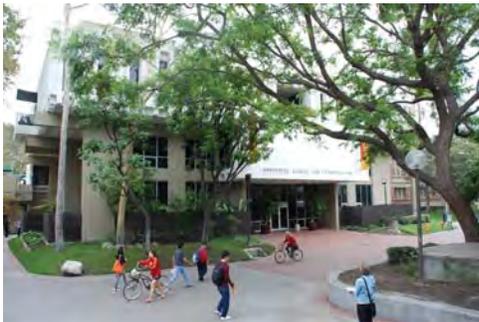
Annenberg School of Communication

A. Quincy Jones & Associates is responsible for the 1976 Annenberg School of Communication, which he designed while serving as the Dean of the School of Architecture and Fine Arts.

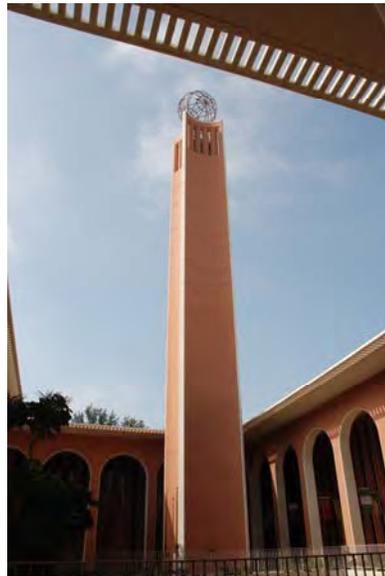
Von KleinSmid Center Courtyard

Edward Durell Stone was another renowned architect who made large contributions to the postwar USC campus. In fact, the University Park campus boasts the largest concentration of E. D. Stone buildings on the West Coast. Like much of his work around the country, Edward Durell Stone's USC buildings were emblematic of New Formalism. His design for the Von KleinSmid Center (VKC, 1964) is one of the campus's most distinctive buildings and has been celebrated by Gebhard and Winter as "the finest of the post-World War II group of buildings on campus." The U-shaped complex is capped by a wide overhanging flat roof and is set off by a globe-topped tower rising from its interior courtyard.

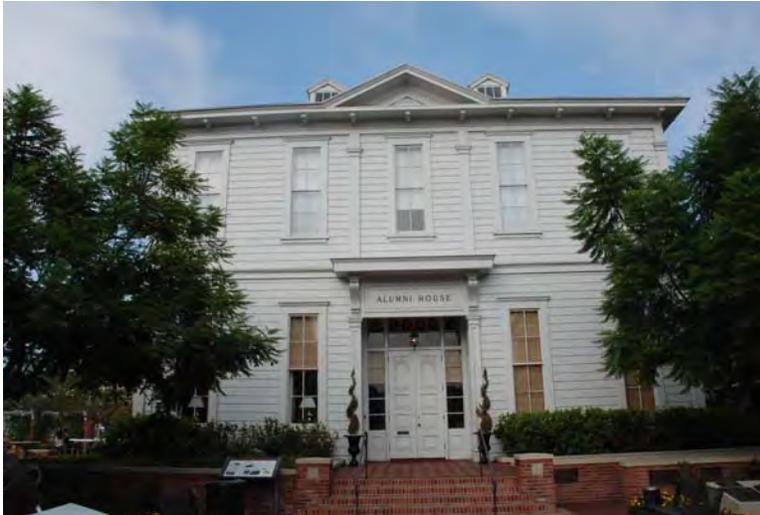
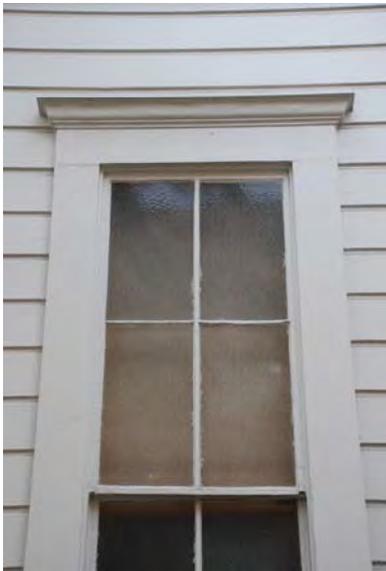
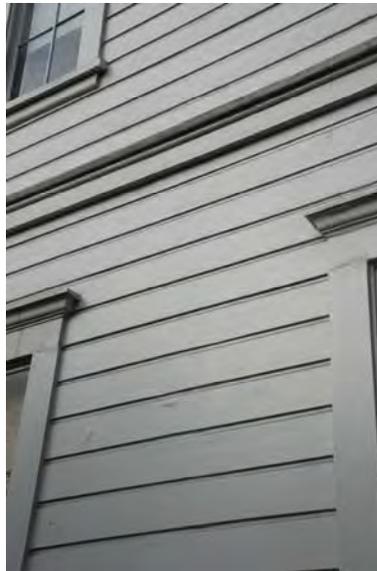
The grounds around this facility are in good condition, including brick plazas, seating areas, and well-maintained landscaping. The shrubs are too close to the building and have caused damaged to the wood clapboard siding.

The exterior painted wood siding was reportedly cleaned, refurbished, and repainted in 2008. However, there is bubbling paint in areas and staining at the drip sills. Exterior doors appear to be in good working order. The double-hung wood sash windows need to be properly restored by scraping off the old paint, repairing and cleaning wood members, then repainting.

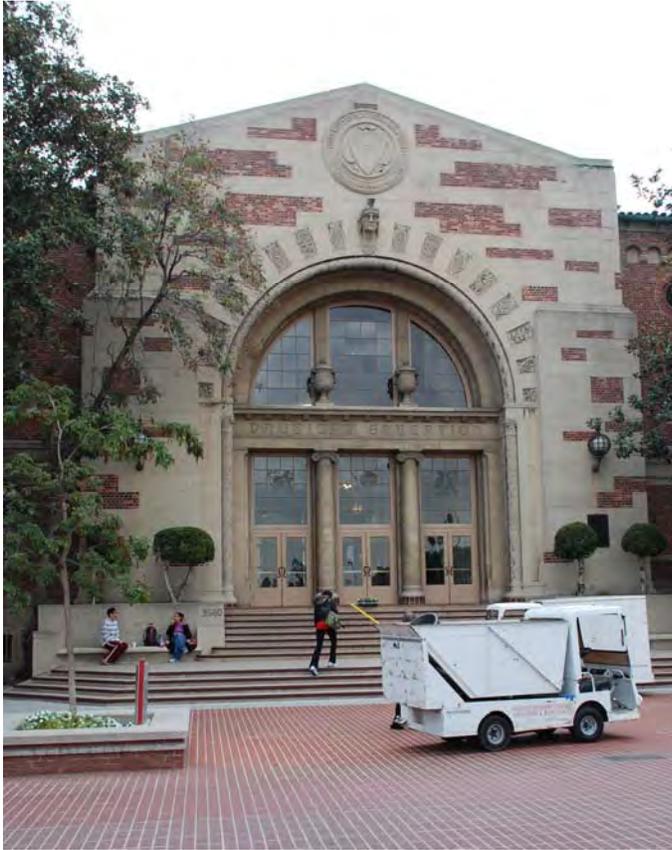
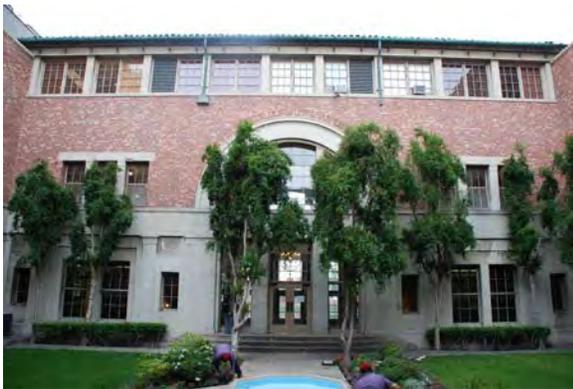
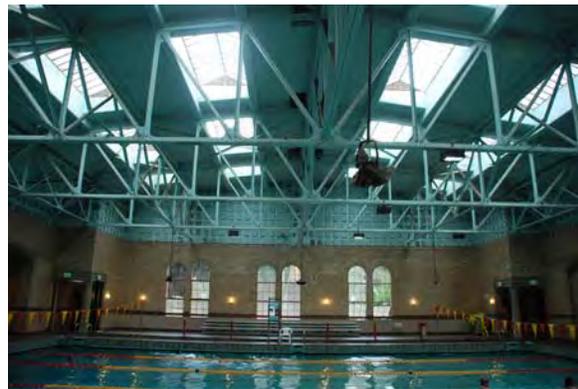
**PED – Physical Education Building**

There are missing mortar joints in the cast stone base. Repoint with a compatible mortar in color and composition.

The wood sash windows in the courtyard are heavily weathered with peeling paint. And, the circular windows are badly damaged. The windows should be cleaned and repaired. If replacement is necessary, they should be replaced in kind.

The steel sash windows at the indoor pool have surface corrosion which has damaged the painted surface. Some of the windows are rusted closed. The windows should be cleaned and repaired. If replacement is necessary, they should be replaced in kind.

Areas where iron railings are attached to or sunk in concrete fences have corroded and caused cracks and damage to the concrete. [Best repair practice?]

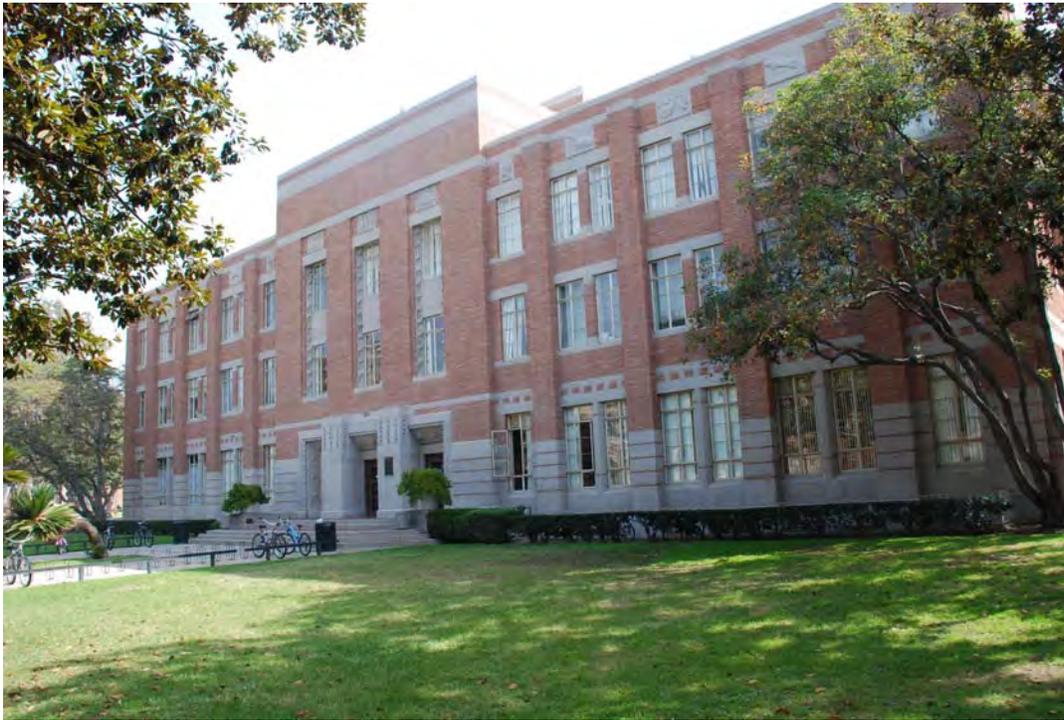
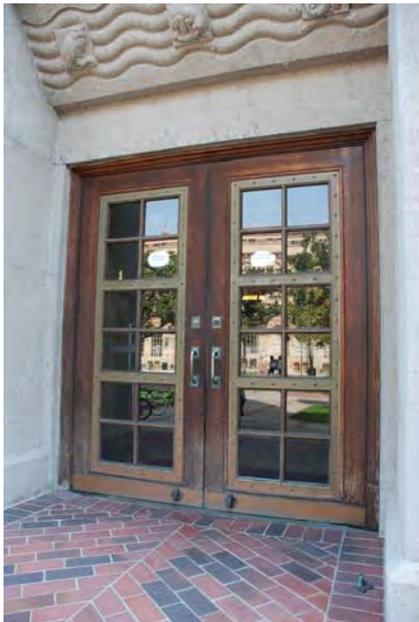
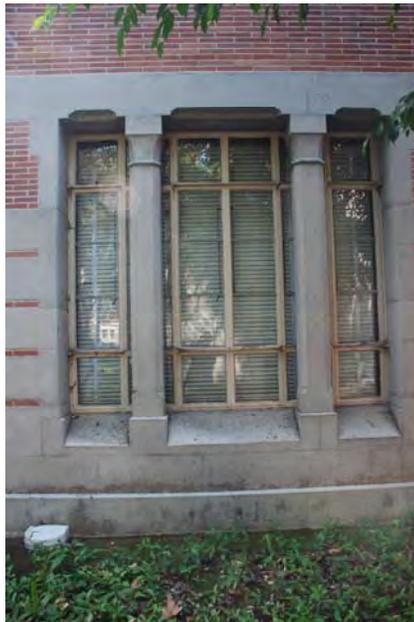
**AHF – Allan Hancock Foundation**

The majority of the brick and cast stone exterior finish is in good condition. However, there are areas of damage that require repair work. The cast stone at the parapet needs the most attention where spalling has exposed the underlying corroding rebar. Check for water infiltration, clean and repair the cast stone surfaces, where necessary.

There is spalling of the concrete at the front entry steps which could be a tripping hazard. Patch and repair concrete. There is map cracking in the concrete piers at the main entry. This may not be an indication of any immediate needed repair, but rather the result of a poor concrete mixture at the time of construction. The cracking should be monitored.

The exterior brick and cast stone surfaces appear to have a rough surface texture that is an indication of past cleaning by sandblasting. It is not recommended that sandblasting be used to clean exterior surfaces in the future as it causes irreparable damage to the historic fabric.

The steel sash windows have surface corrosion which has damaged the painted surface. Some of the windows are rusted closed. The windows should be cleaned and repaired. If replacement is necessary, they should be replaced in kind.

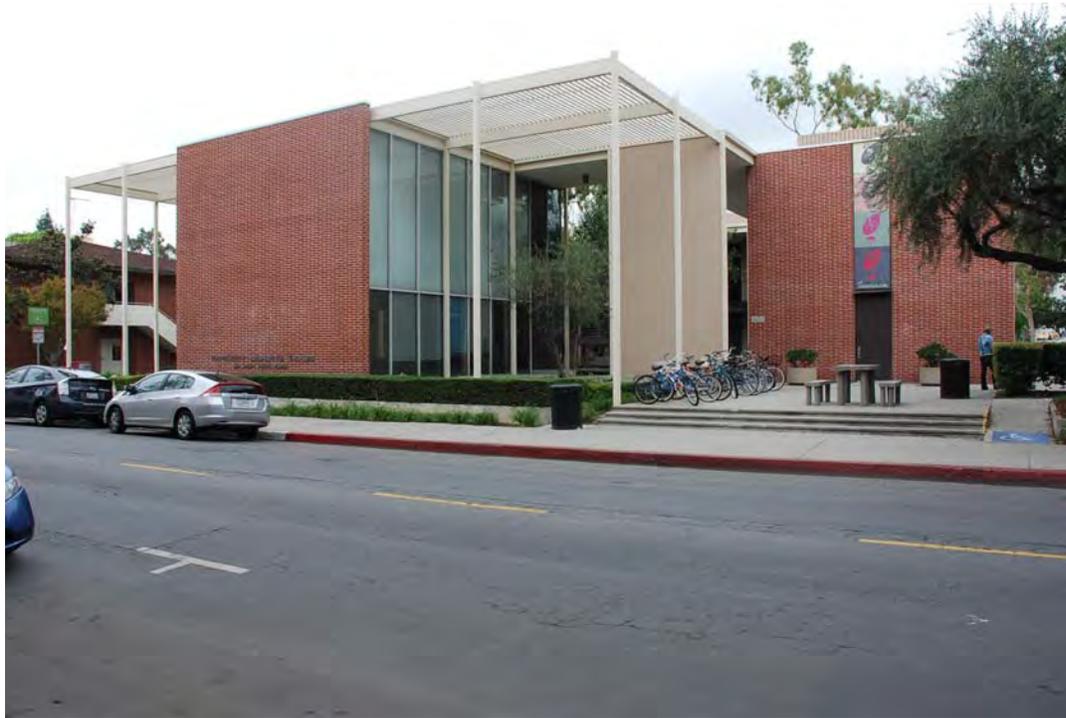
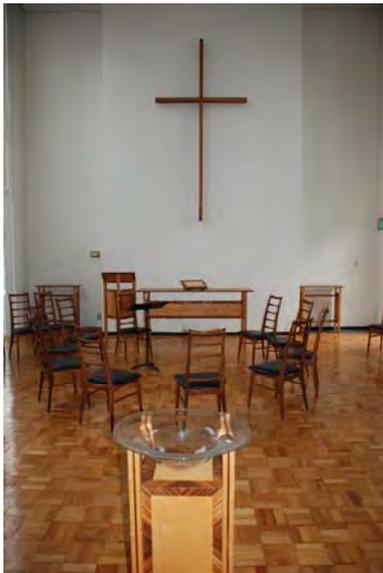
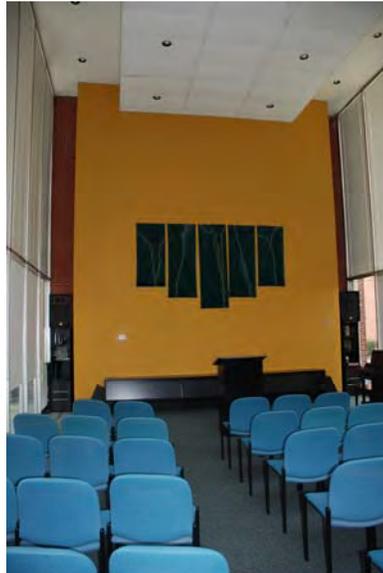
**URC – University Religious Center**

The roof system may need to be replaced to prevent further damage of interior finishes due to water infiltration.

The exterior brick and stucco cladding are in generally good condition. The exterior doors are in good working order. The aluminum framing of the window walls have minor surface corrosion. [Best repair practice?]

The acoustical tile ceiling systems are stained and sagging from water infiltration and should be replaced in kind after the source of the leak is repaired.
